Structural Inspection Report

Flat 3/3, 18 Dunn Street, Paisley

Balfour Engineering Consultancy Ltd

Ref 14466/FD

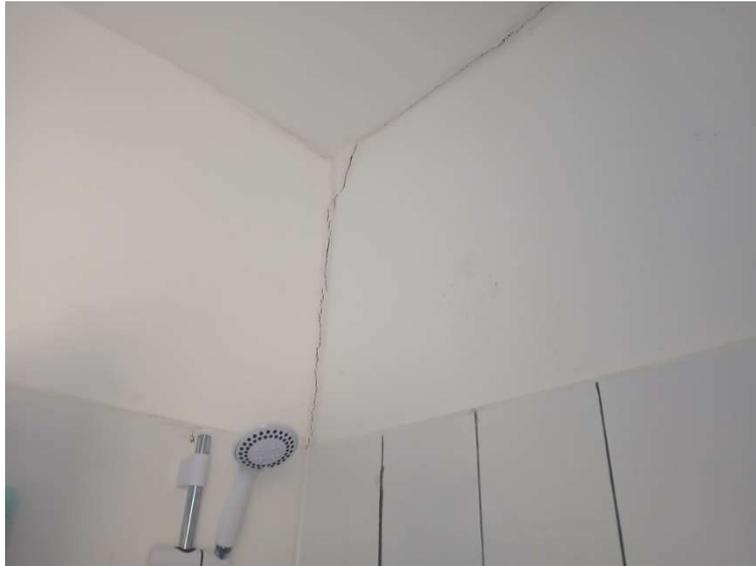
Internally there were a number of horizontal and vertical separation cracks noted at different locations within the property. The worst were within the bathroom and hallway adjacent to the bathroom. Refer to photographs 1-6.

Photograph No.1 – Vertical crack between cross walls and along ceiling in bathroom on gable wall.

Irrespective of the site findings in the first instance crack stitching must be undertaken to improve the connection between the walls. Reference should be made to initial information given within Appendix C for Helifix crack stitching bars and methodology.

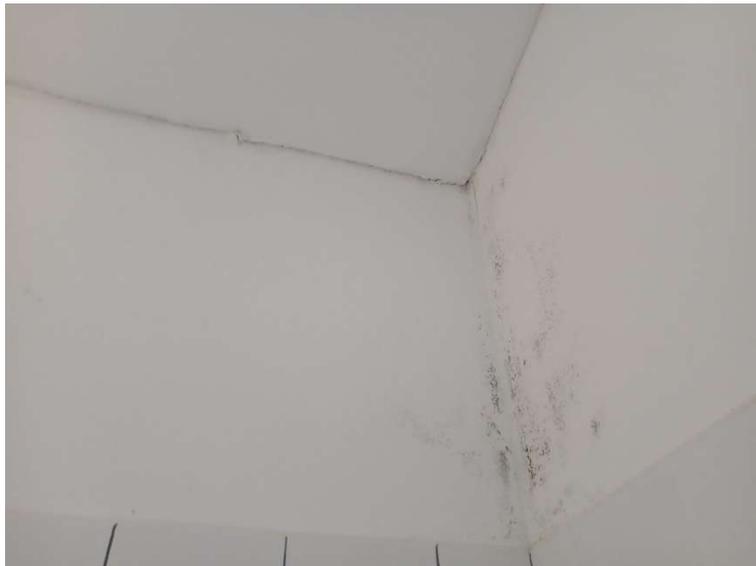
Photograph No.2 – Horizontal crack extending towards the southwestern corner of the building.

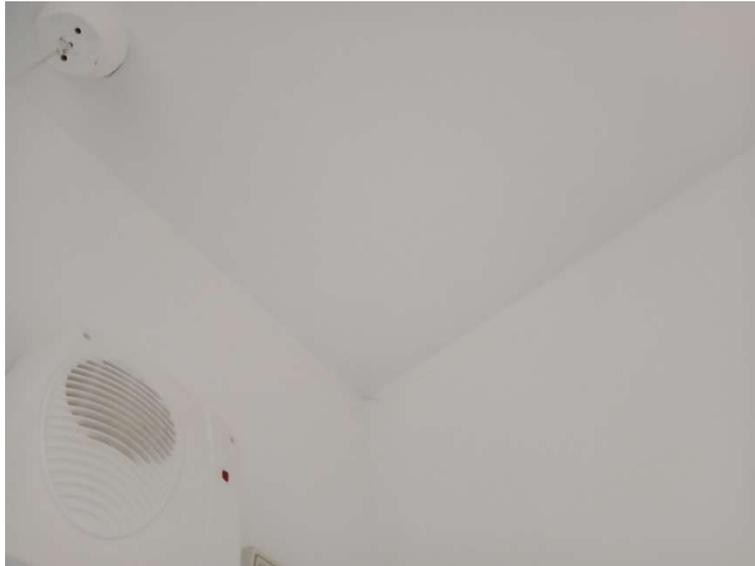
Photograph No.3 – Horizontal crack at ceiling/wall juncture to internal wall within bathroom.

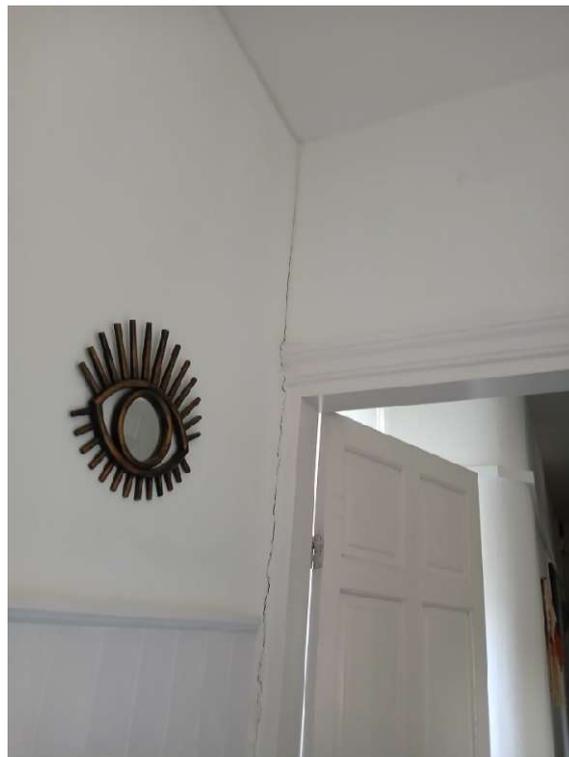
Photograph No.4 – Vertical crack at door junction of architrave and rear external wall from within bathroom.

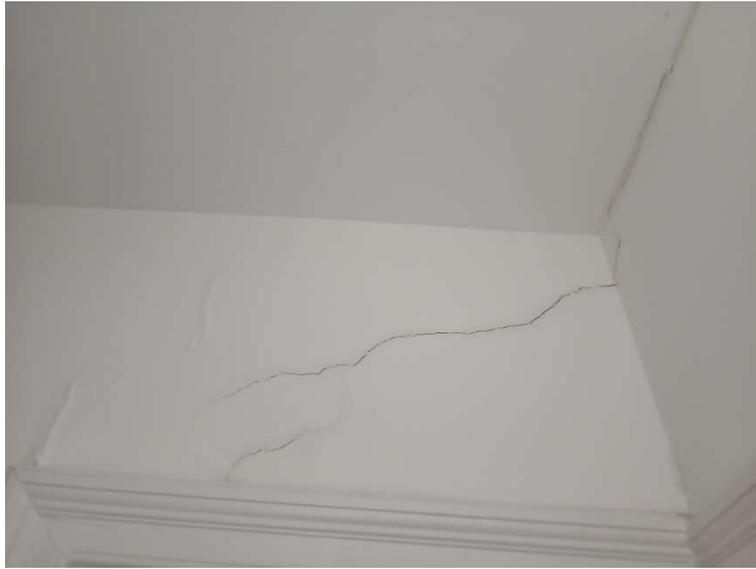
Photograph No.5 – Diagonal cracking above door into bedroom from hallway.

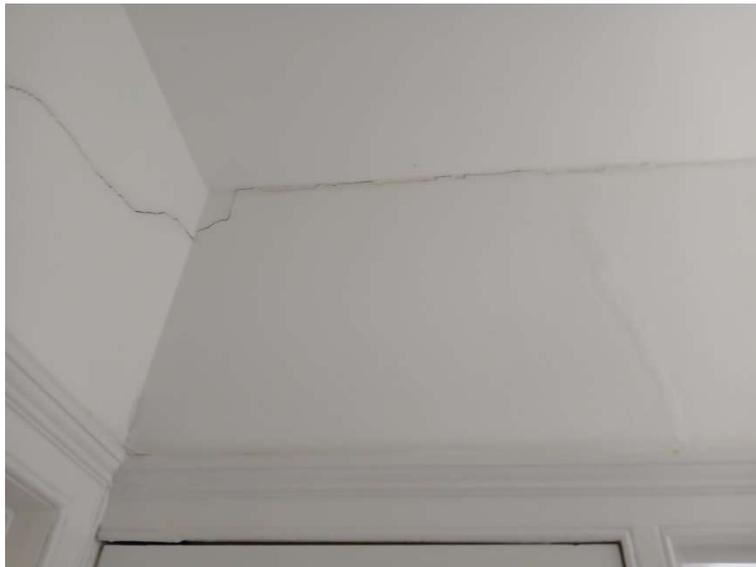
Photograph No.6 – Crack extends across bathroom wall from photograph 5.

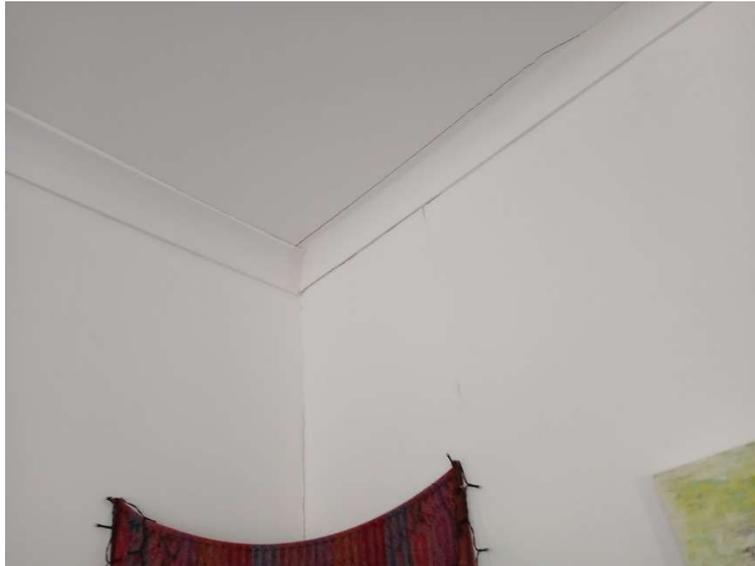
Similar cracking was also noted within the bedroom, photographs 7 & 8.

Photograph No.7 – Horizontal cracking at wall/ceiling juncture within bedroom, on opposite side of wall from bathroom.

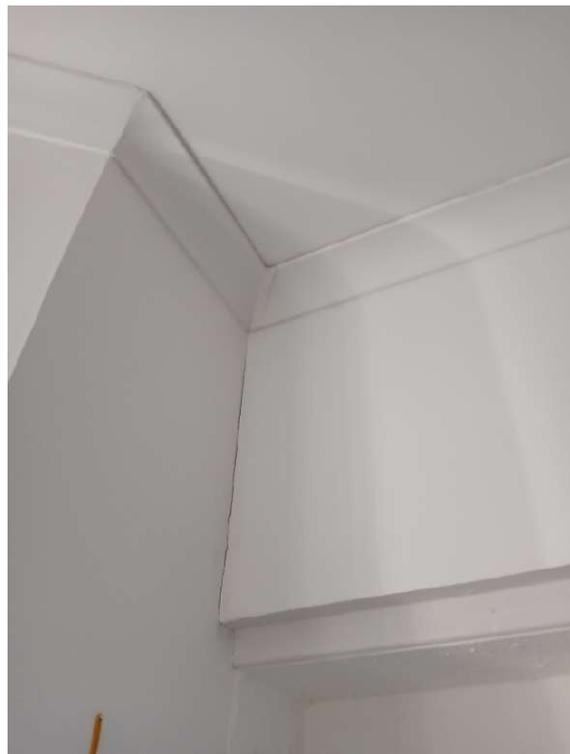
Photograph No.8 – Cracking extending along gable wall at high level along full length of gable.

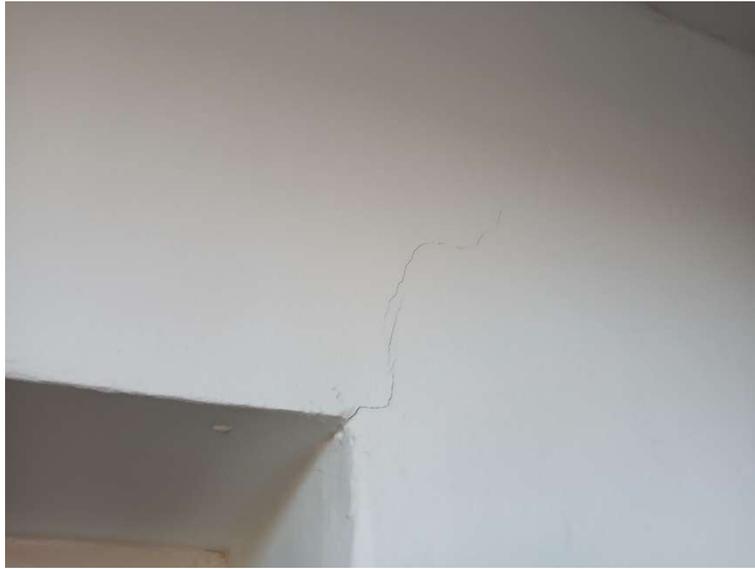
Diagonal cracking could be seen above the door in the kitchen. Photograph 9.

Photograph No.9 – Diagonal crack leading up from kitchen door, within kitchen.

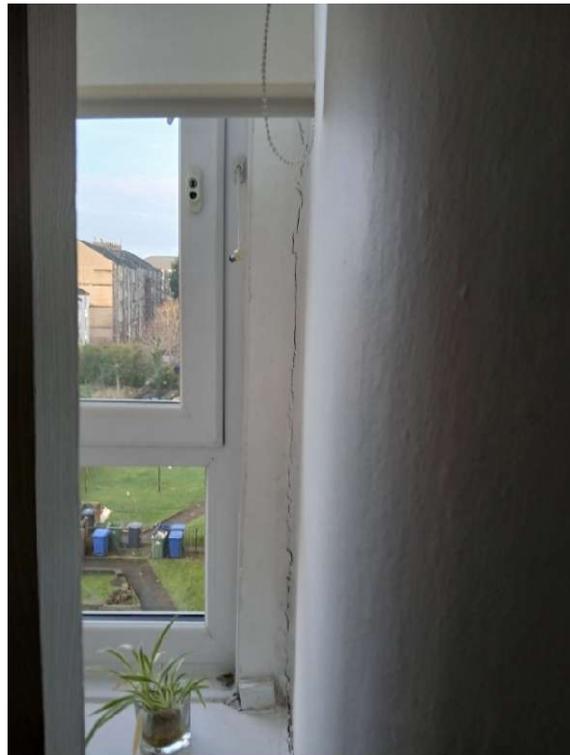
At the window overlooking the rear courtyard cracking was noted at the side of the window across the full height of this area. Photograph 10.

Photograph No.10 – Cracking at window reveal rear wall.

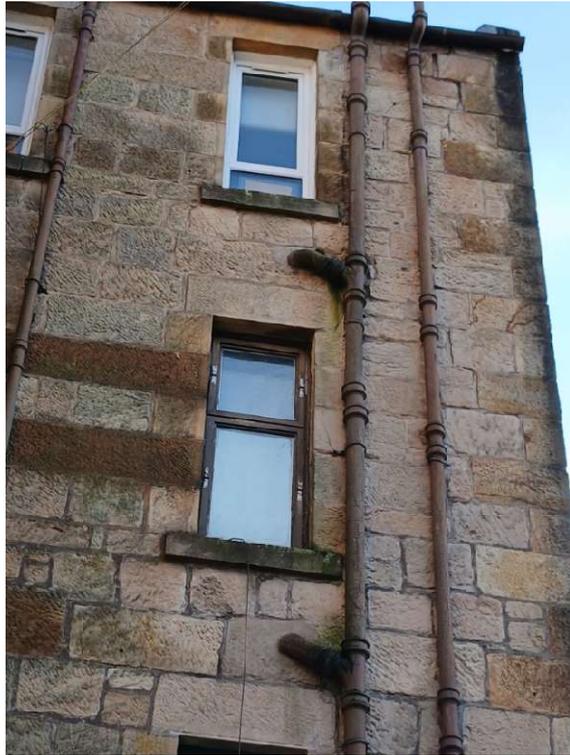
Externally there were signs of cracking and opening up of joints in and around the quoins on both the northern wall and western gable. The joint widths were worst towards the top of the walls. Refer to photographs 11-17.

At present there is a degree of movement within the western gable which appears to be the root cause of the defects noted within the flat. There are a number of potential causes for the movement. Some further exploratory works will be required to rule out some of the potential factors prior to undertaking repair works.

Photograph No.11 – Step crack/open joints on north elevation wider at top of wall getting narrower towards base.

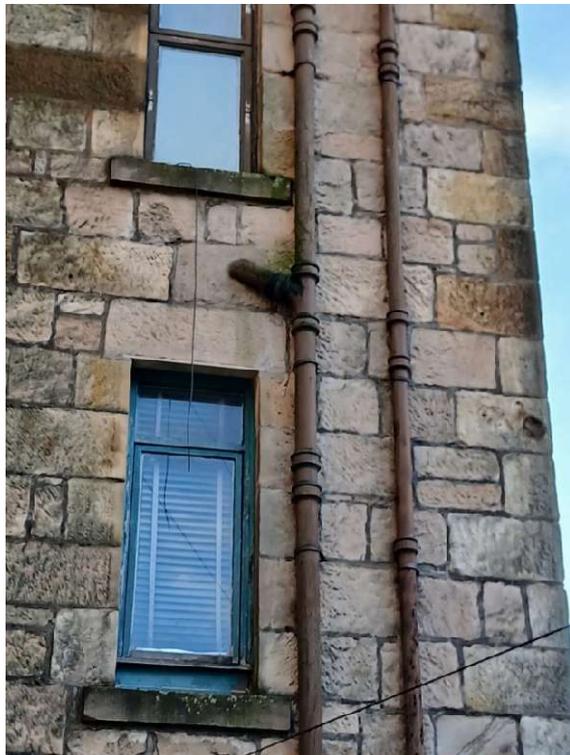
Photograph No.12 – Continuation from Photograph 11.

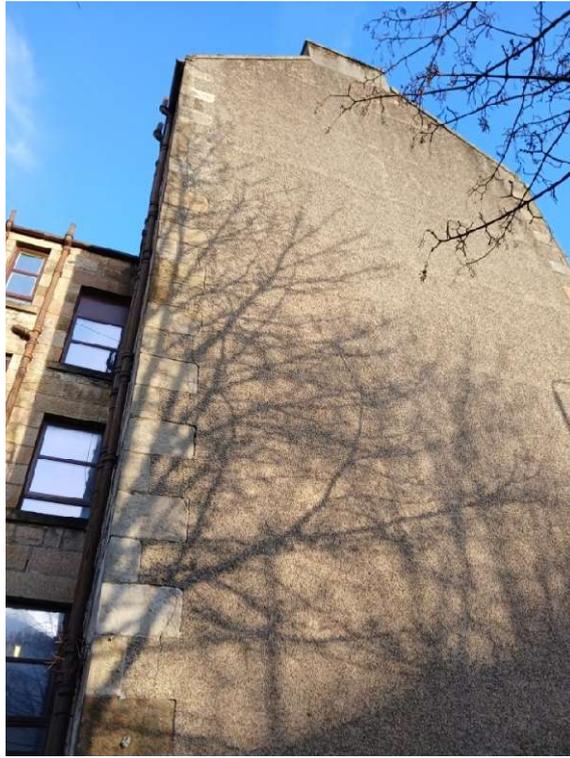
Photograph No.13 – Cracking visible in quoins and between quoins & roughcast on northern side of gable.

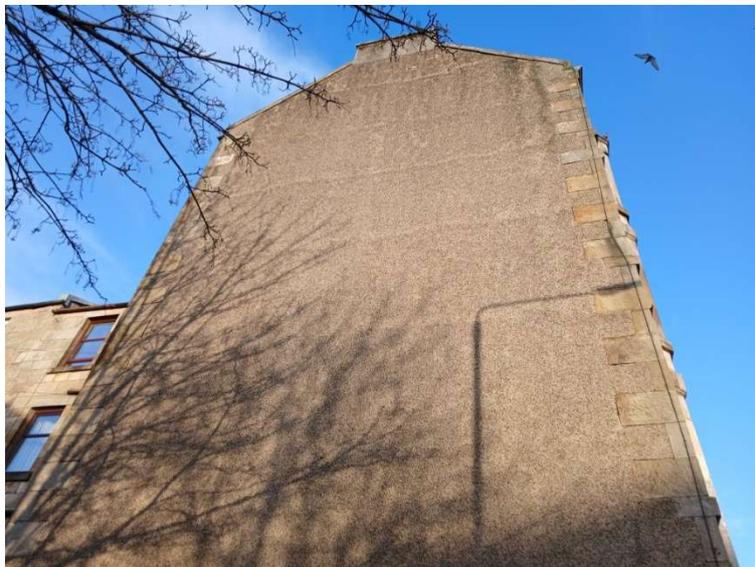
Photograph No.14 – Alternate view of cracking visible on both sides of gable.

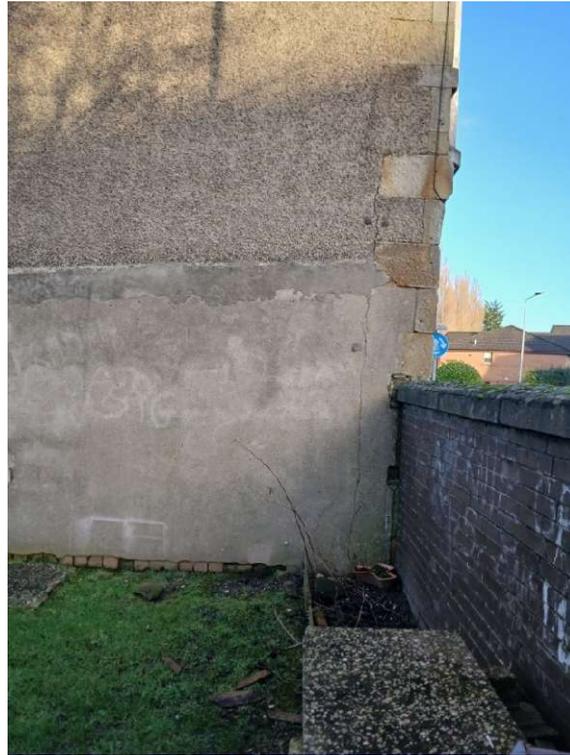
Photograph No.15 – Cracking extending to base of wall.

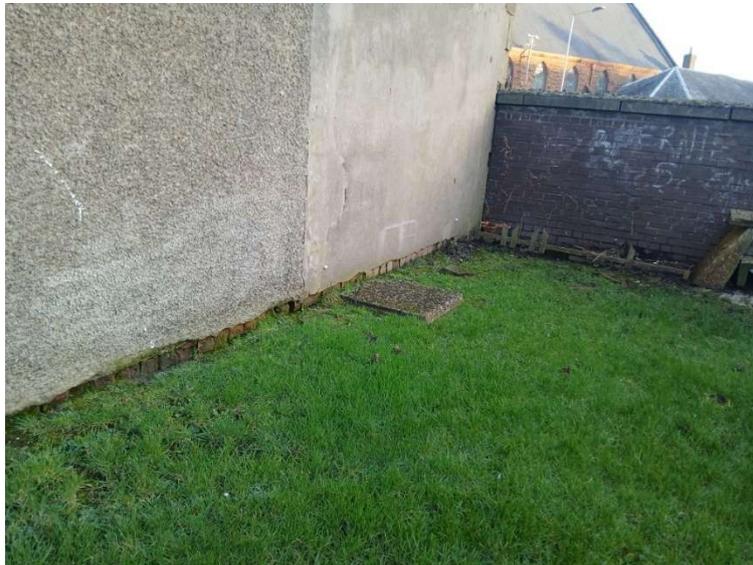
- Potential movement due to washout of subsoils below the gable foundations.
 - o Two manhole covers were noted close to the base of the gable wall. The covers were not lifted. An inspection should be undertaken within the assumed below ground drainage pipes running parallel to the gable. It should be confirmed whether there are any leaks or other defects within the pipe which may be causing an instability to occur in the wall.

Photograph No.16 – Manhole adjacent to gable.

- o Where defects are found then these should be made good prior to any remedial works being undertaken.
 - o Remedial works to the foundations would vary dependent upon the extent of washout or damage found. Allowance should be made for locally underpinning at the washed out area, and at the corners of the building.

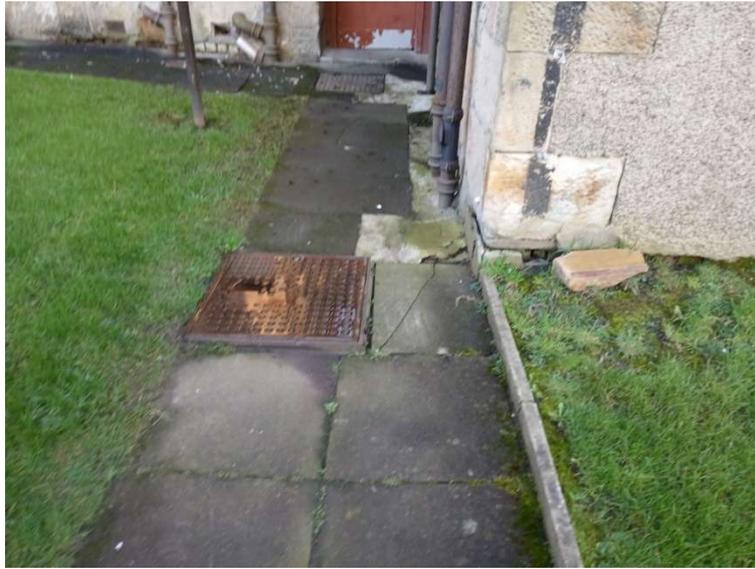
Photograph No.17 – Cracking extending to base of wall, north-western corner of gable.

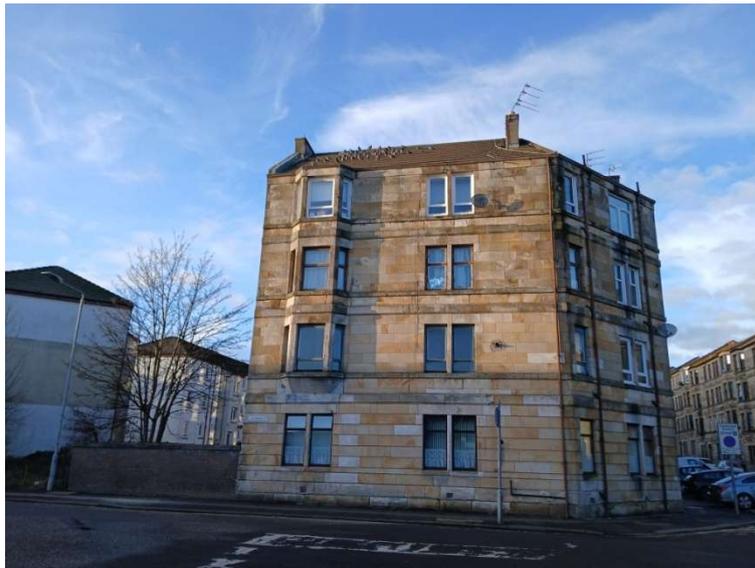
When viewed from Ladyburn Street there were no obvious signs of defects noted to the walls or roof. Photograph 18.

Photograph No.18 – View of property from Ladyburn Street. No visible defects on southern elevation.
